WASTE WATER TREATMENT PLANT AND INCINERATOR COMPLEX,
SITES 5EP2447 AND 5EP2446,
FORT CARSON, COLORADO

James Schneck
and
Karin M. Roberts

United States Department of the Interior
National Park Service
Midwest Archeological Center
Lincoln, Nebraska

September 1998

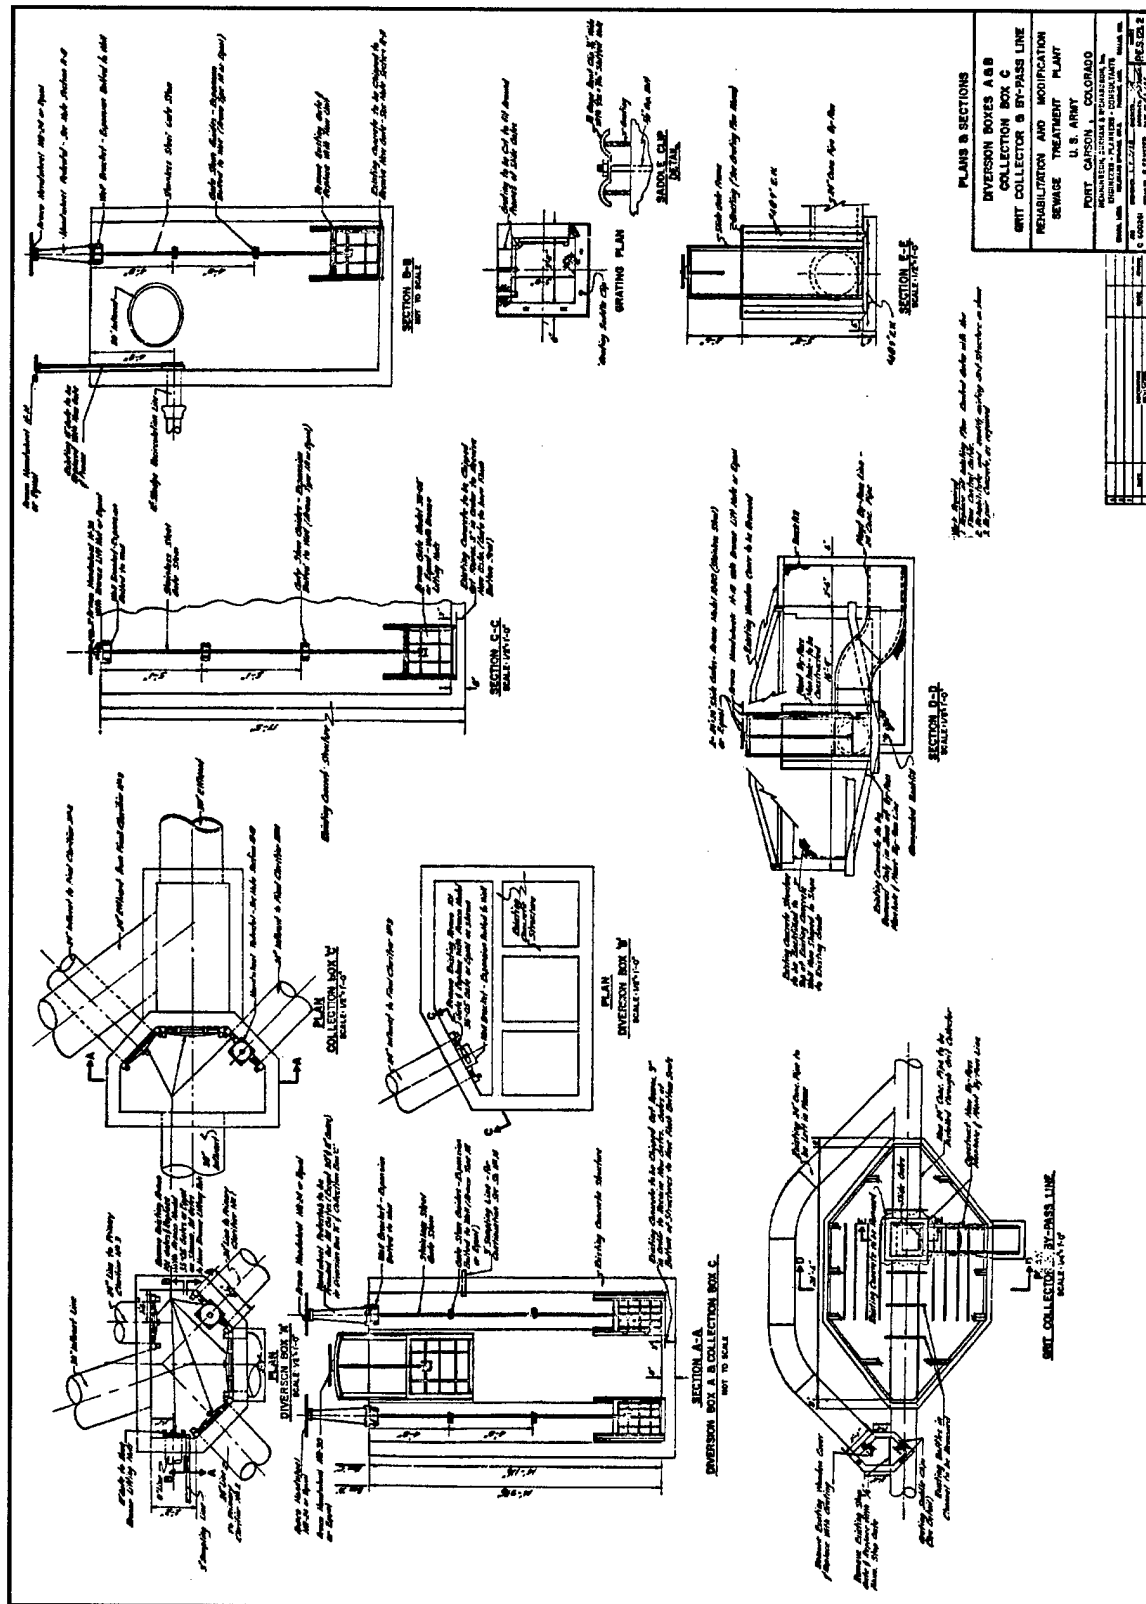
Figure II-17. Plans, sections, and details for Diversion Boxes 3875, 3890 and 3891. Diversion Boxes A and B - Collection Box C - Grit Collector and By-Pass Line. Plan PES.121.2. Note that 3875 is Box 'A' on plan, 3890 is Box 'B', 3891 is Box 'C'.

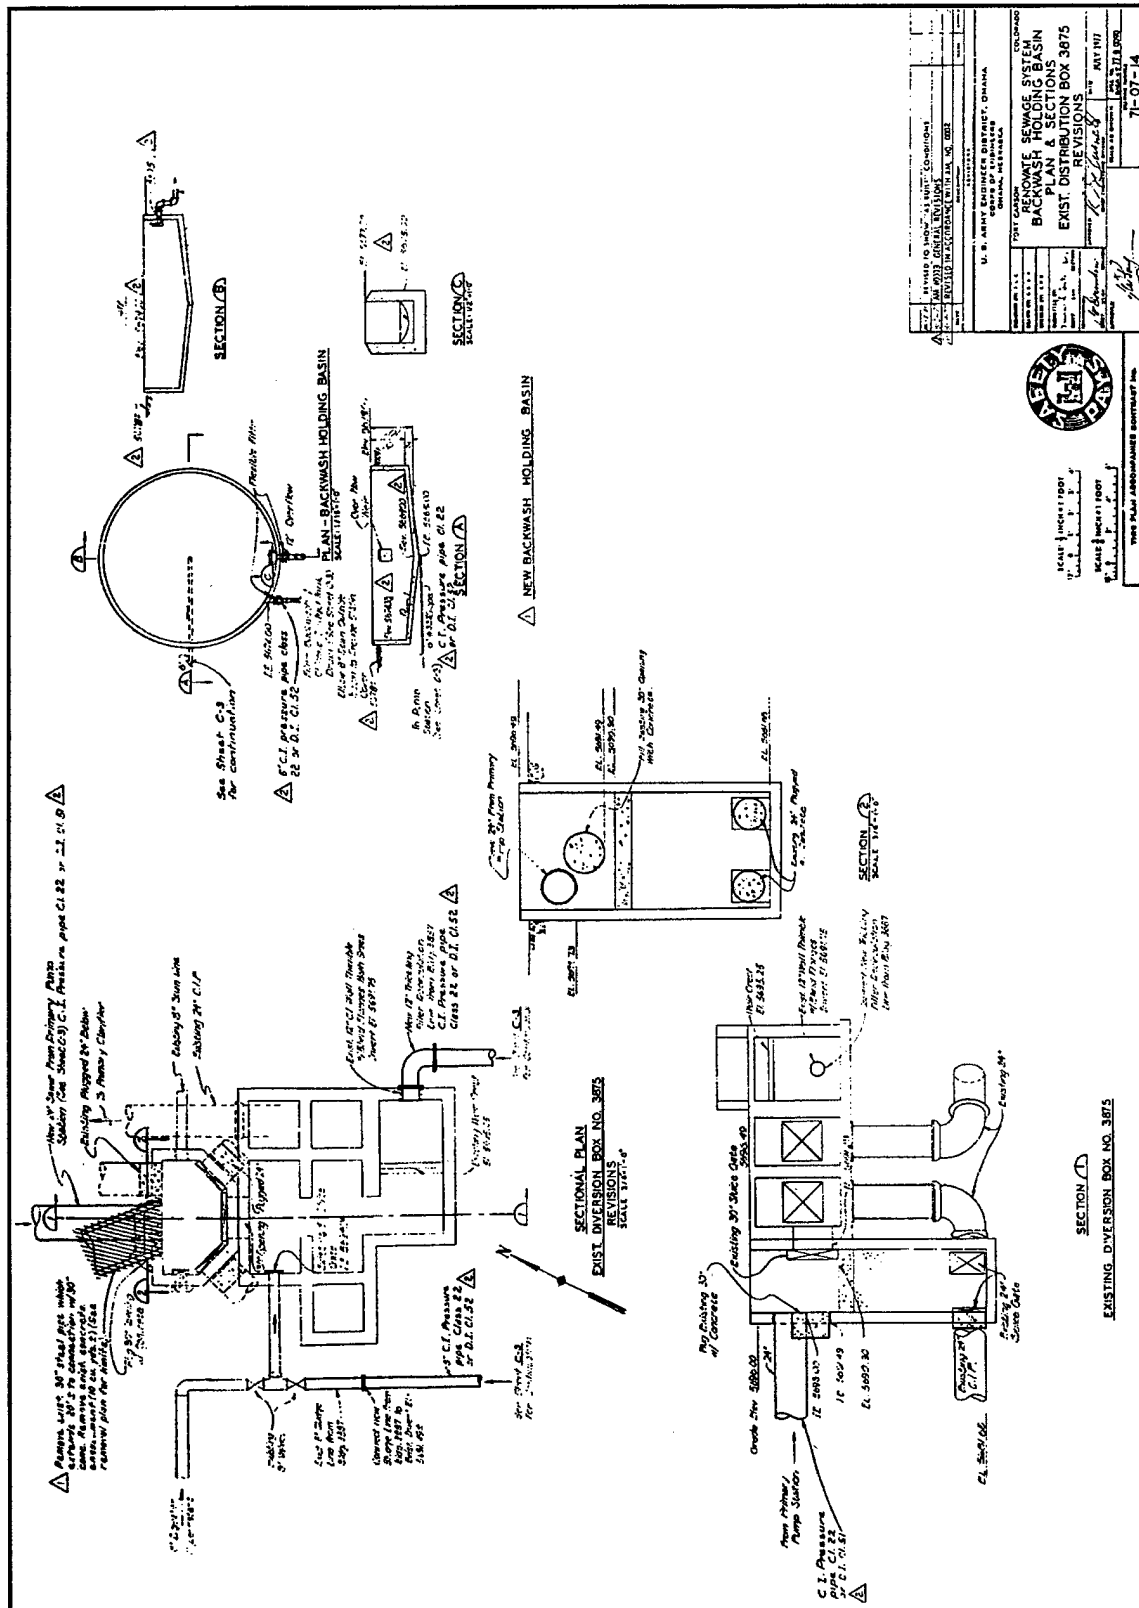
Figure II-18. Plans and sections for Diversion Box 3875. Backwash Holding Basin Plan and Sections - Existing Distribution Box 3875 Revisions. Plan 71-07-14, Sheet C29. Note six-bay addition on downstream side.

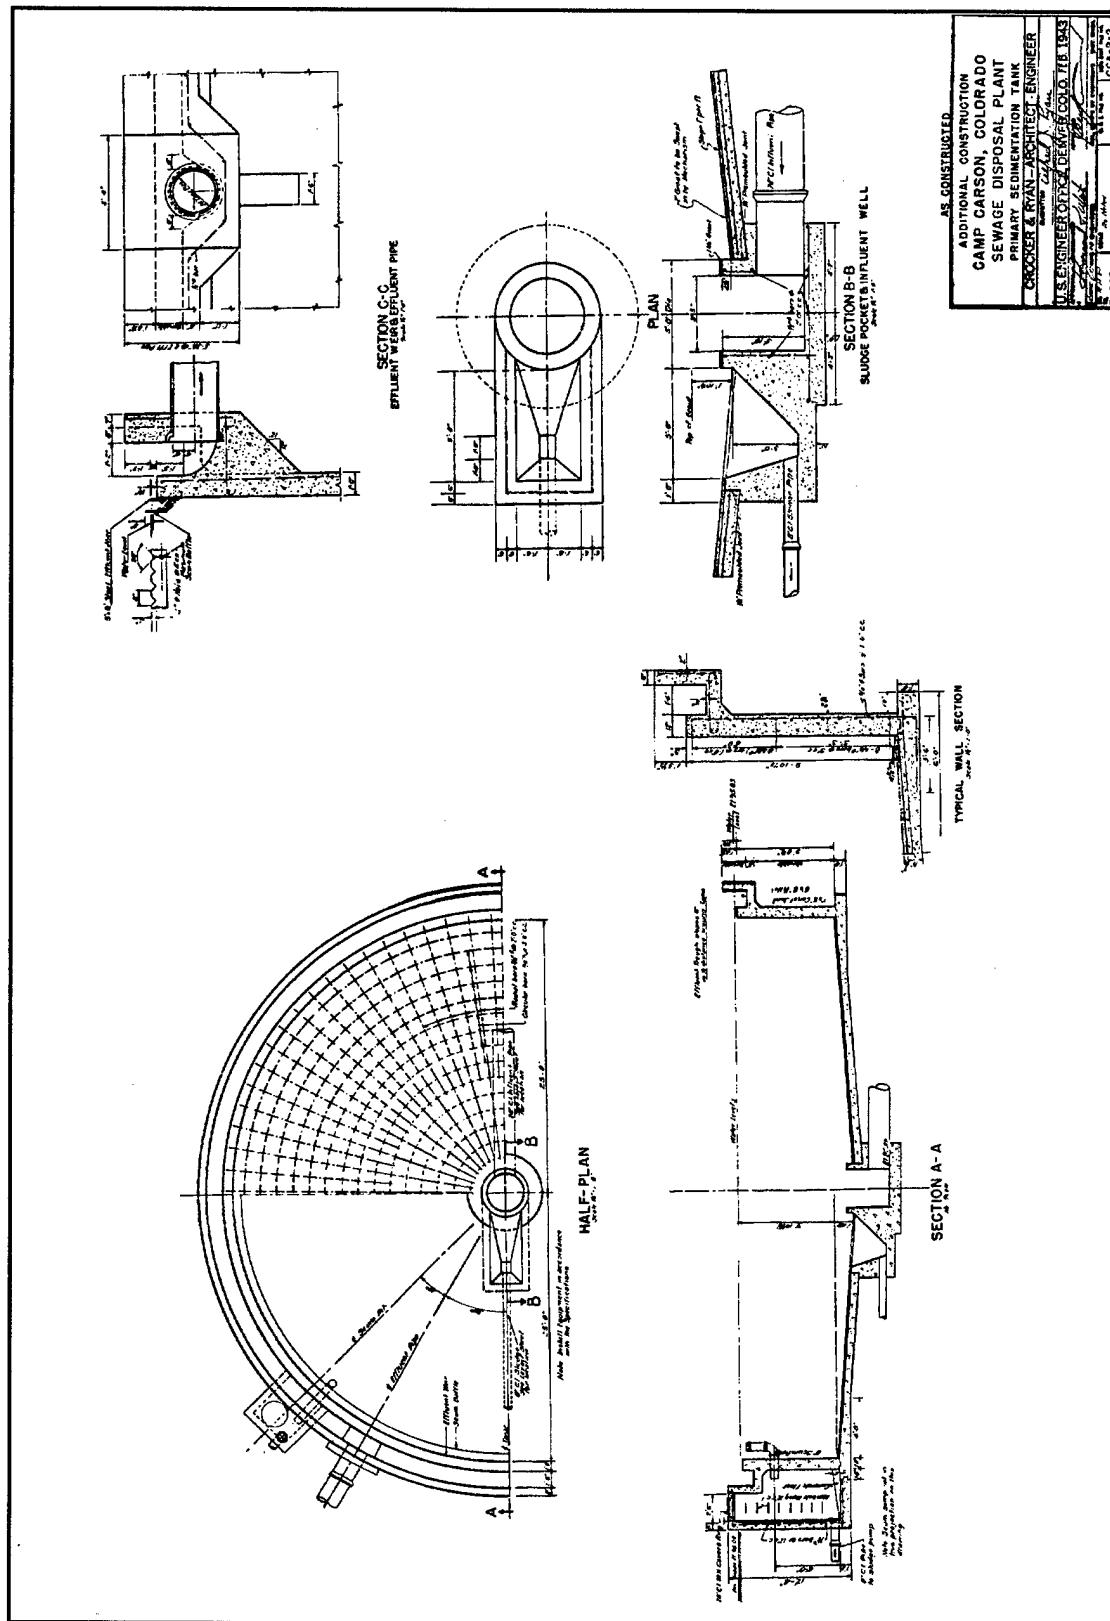
Figure II-19. Plans, sections, and details for Primary Clarifiers 3876, 3877, and 3879. Sewage Disposal Plant - Primary Sedimentation Tank. Plan CCA-2-2 3S.

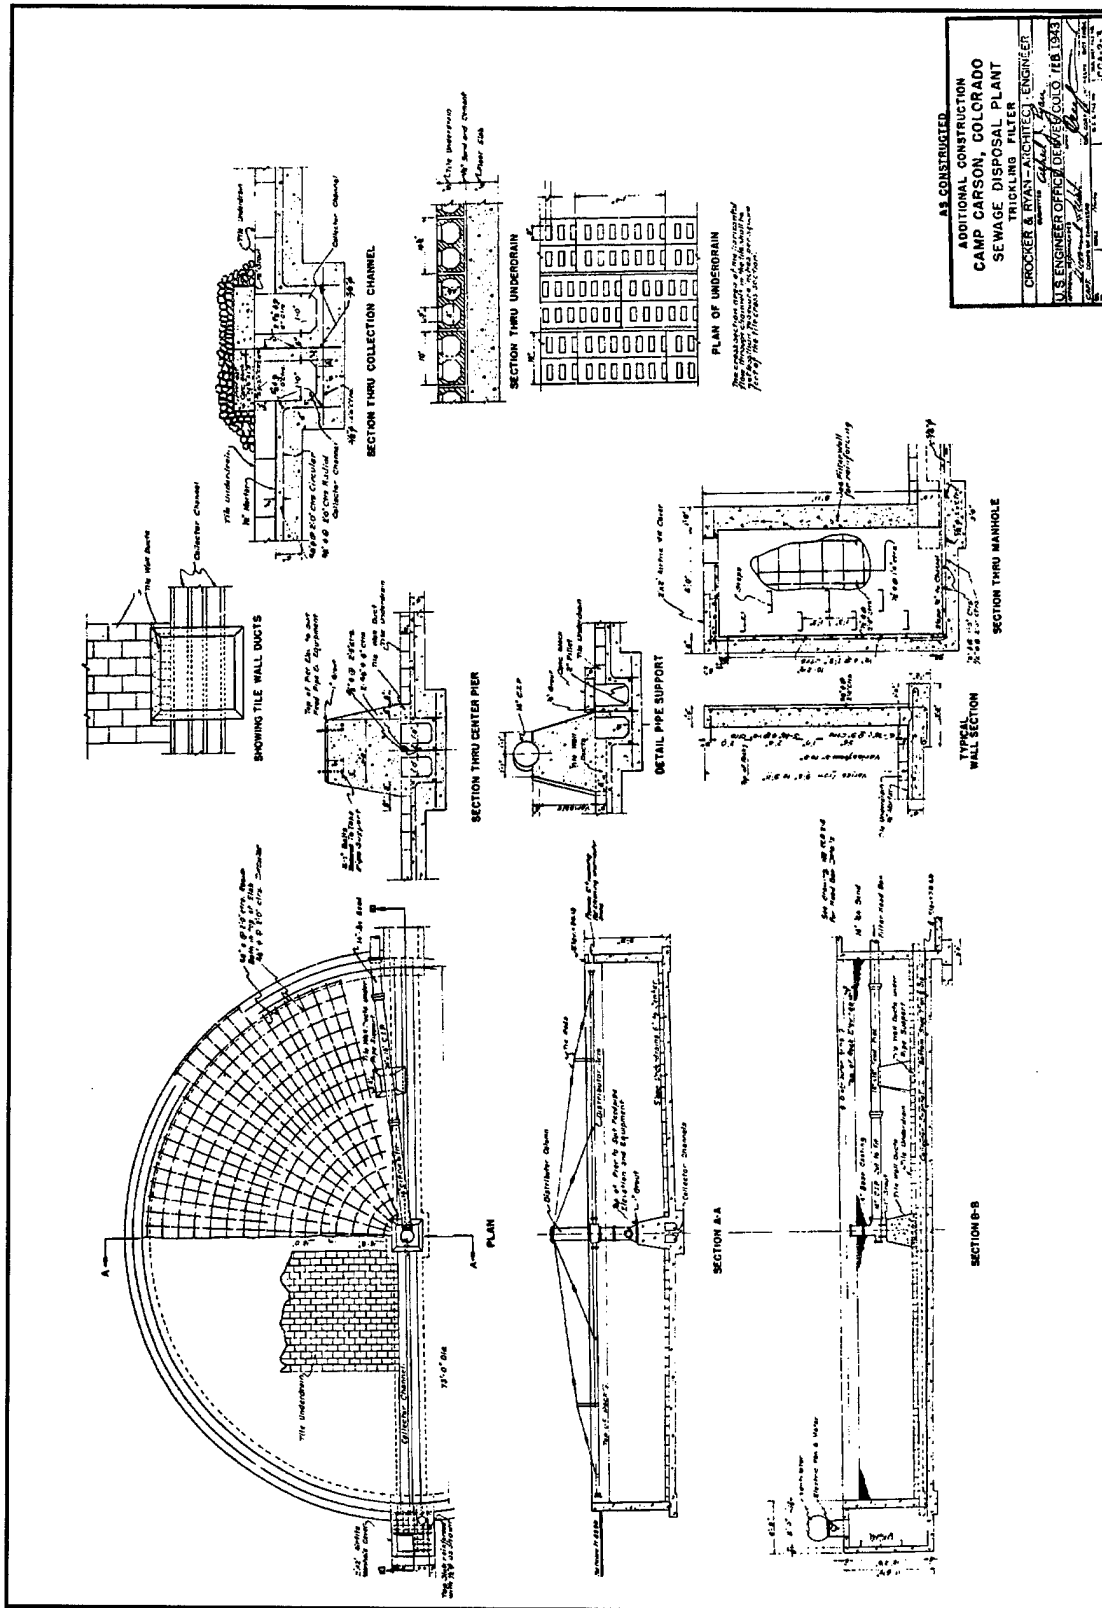
Figure II-21. Plans, sections, and details for Trickling Filters 3881, 3883, 3884, and 3886. Sewage Disposal Plant - Trickling Filter. Plan CCA-2-3.

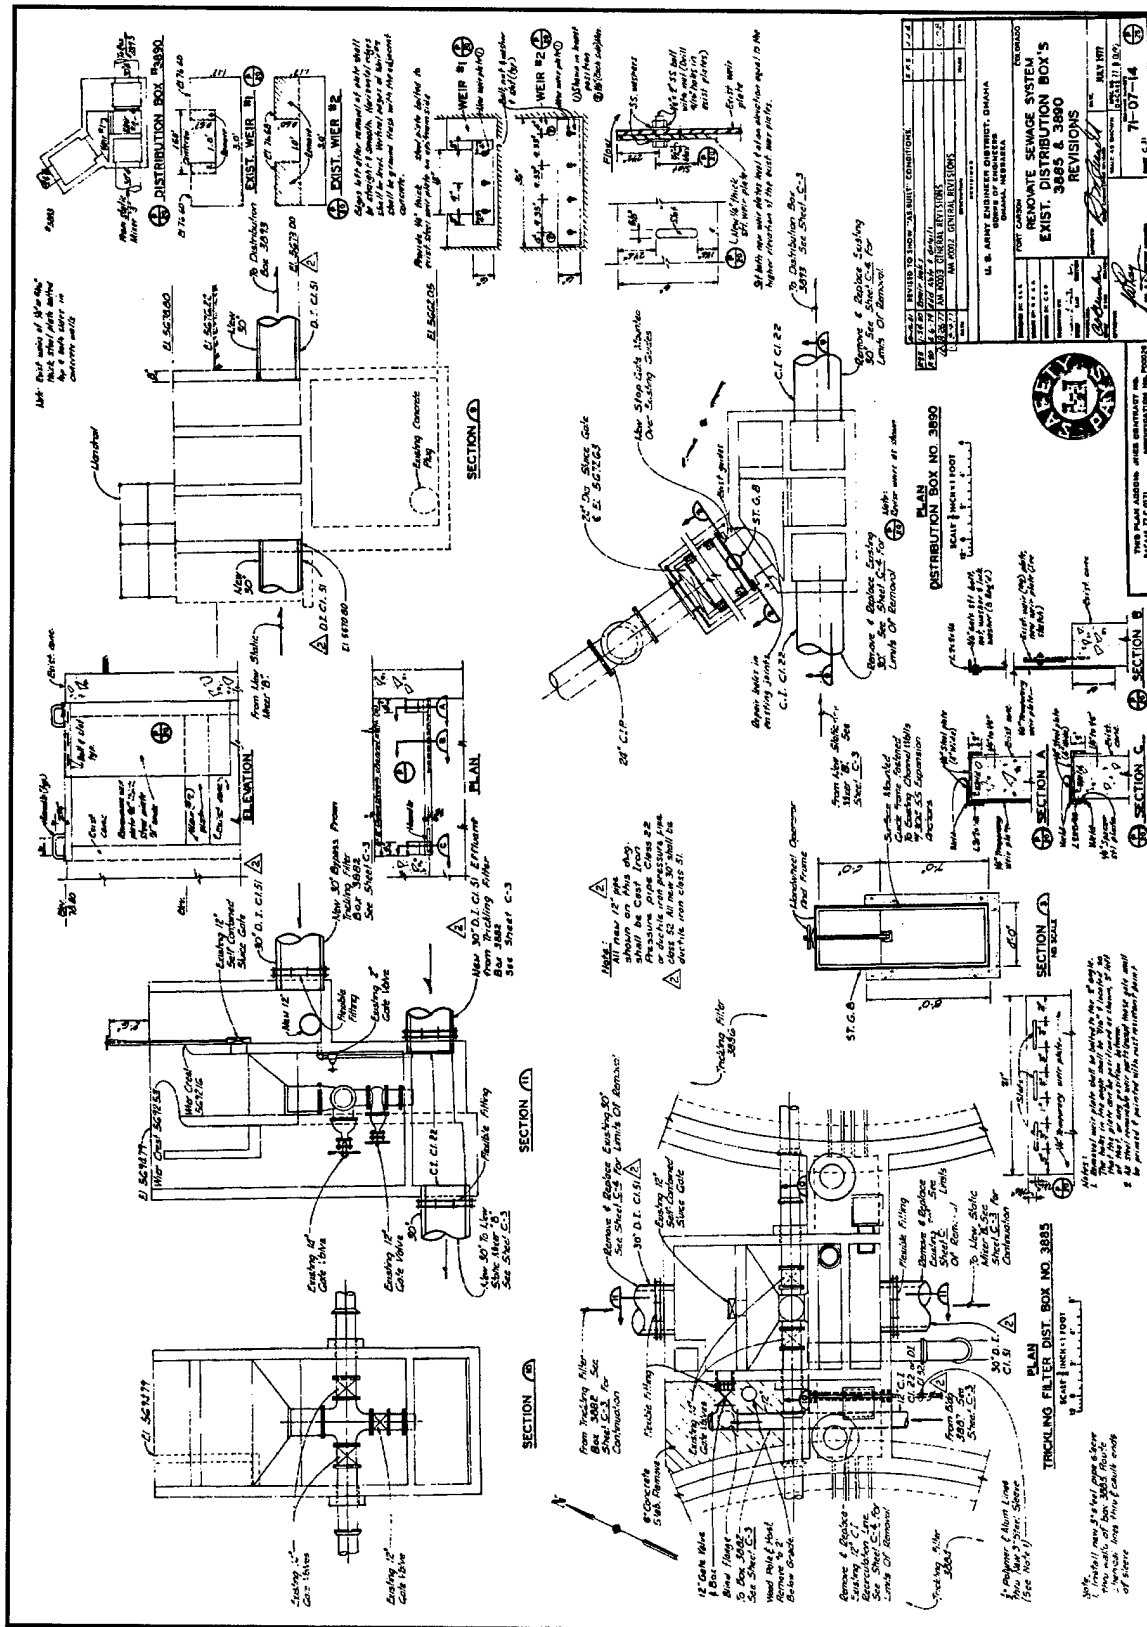
Figure II-23. Plan, sections, and equipment layout for Filter Head Box 3885; plan and section for Diversion Box 3890. Existing Distribution Boxes 3885 and 3890 - Revisions. Plan 71-07-14, Sheet C31. Note that angled leg at 3890 is addition.

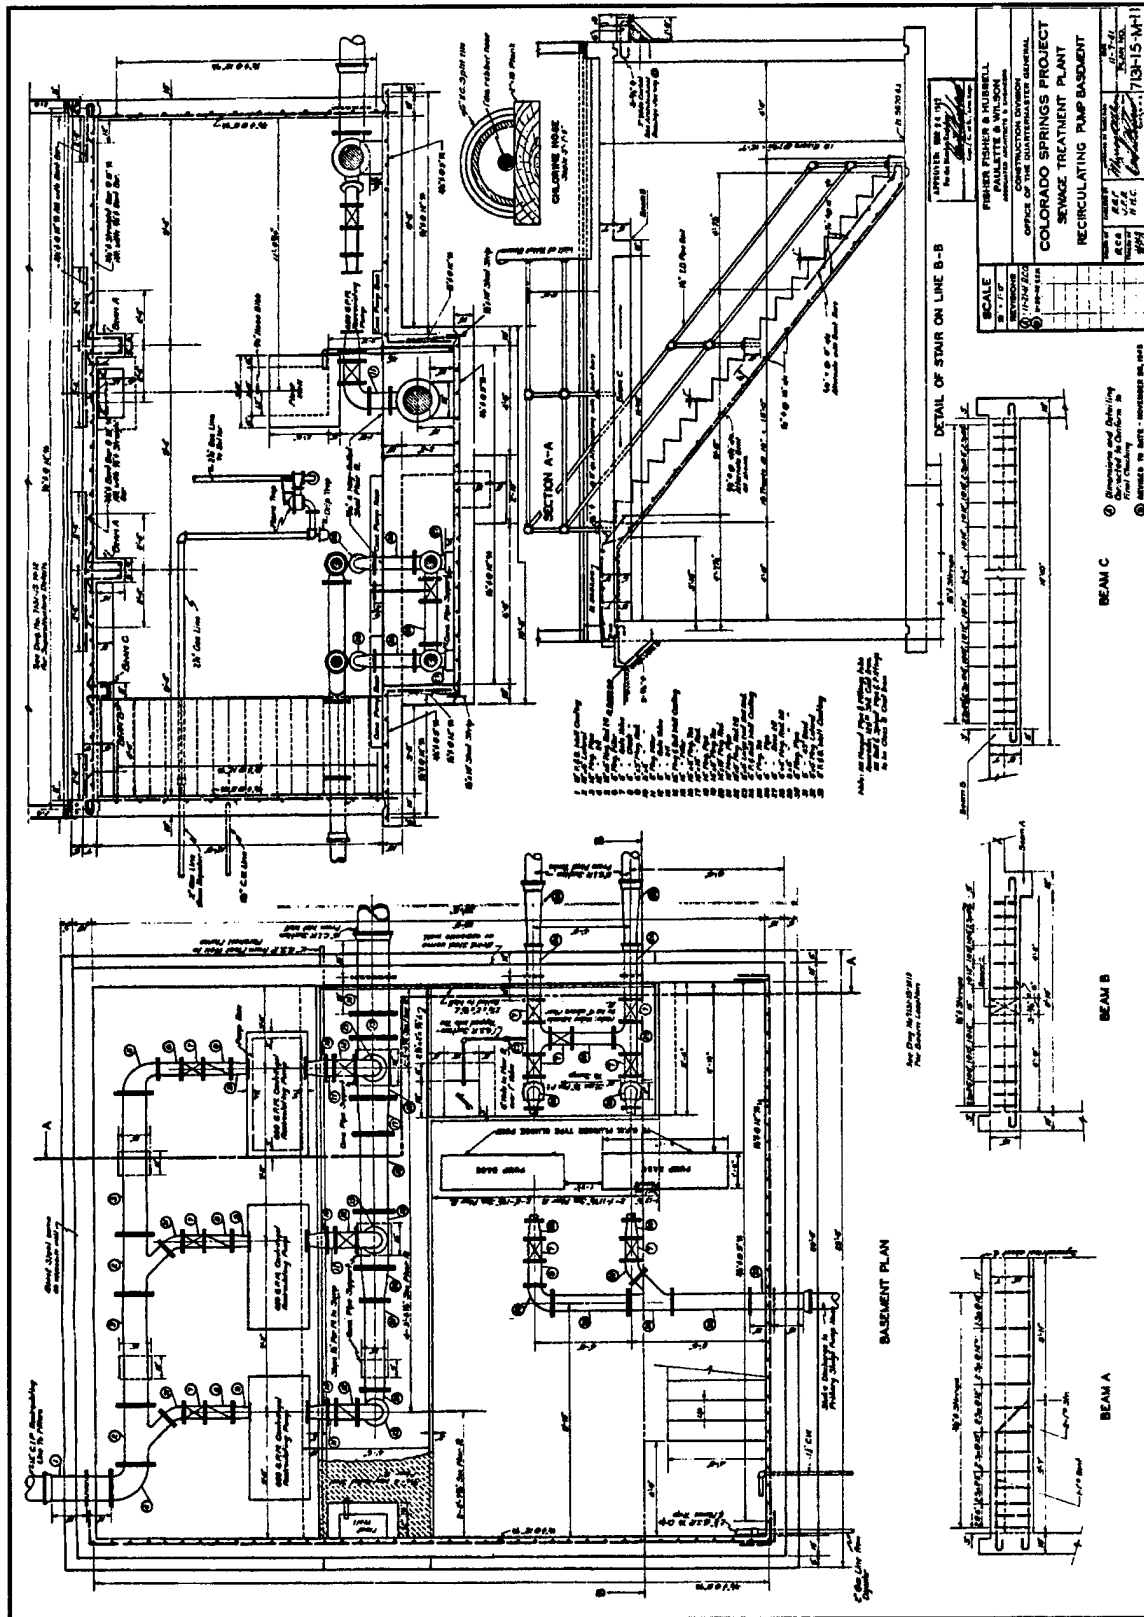
Figure II-24. Plans, sections, and details for pump room at Laboratory and Control 3887. Recirculating Pump Basement. Plan 7131-15-M11 2G.

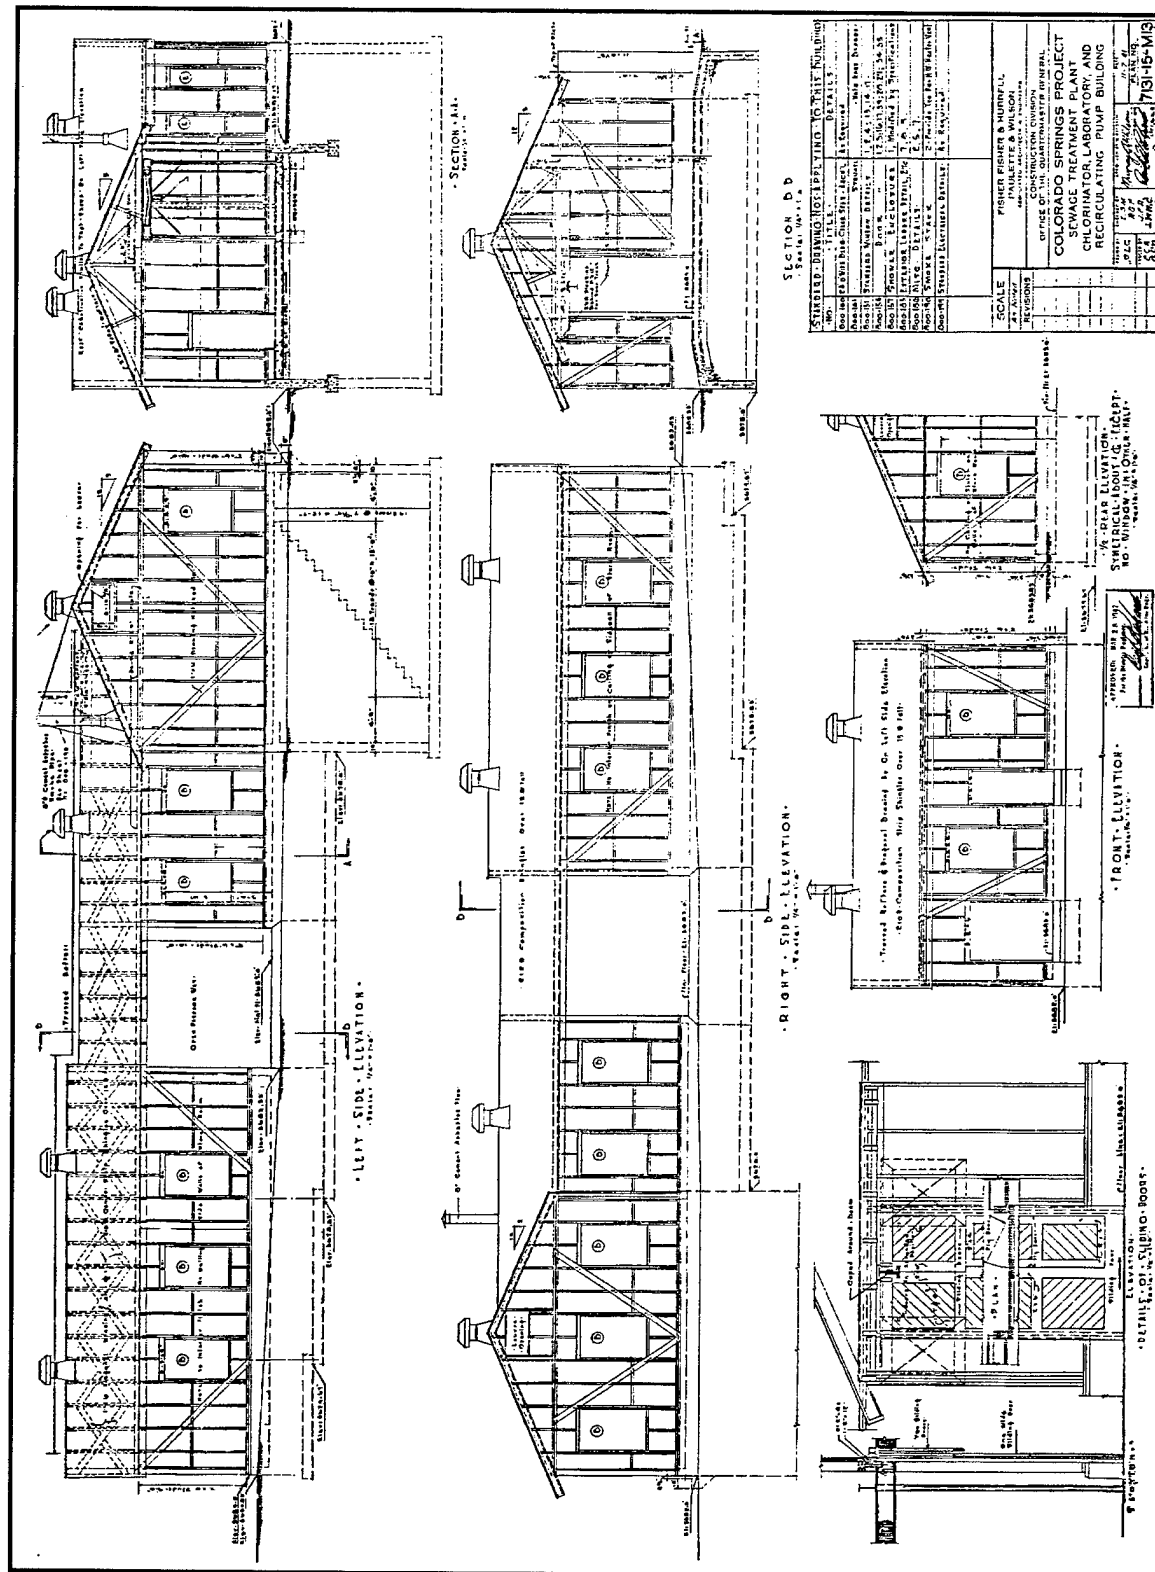
Figure II-25. Framing plans, sections, and details for Laboratory and Control 3887. Chlorinator, Laboratory, and Recirculating Pump Building. Plan 7131-15-M13 2G.

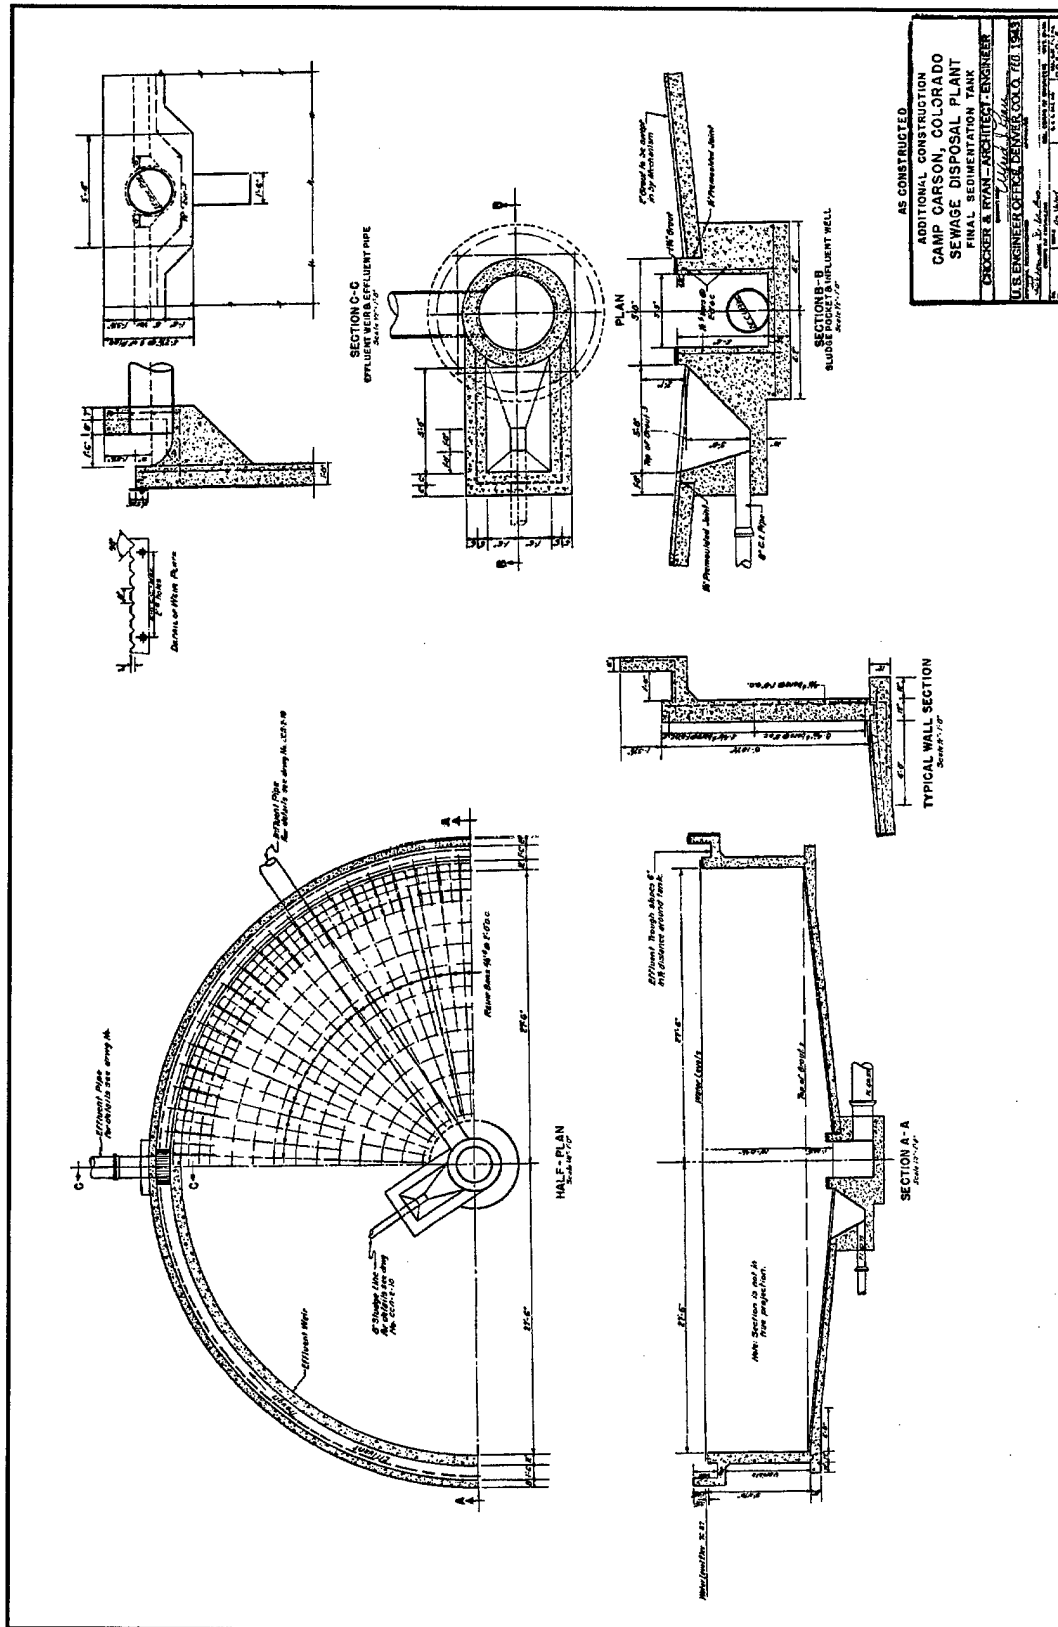
Figure II-27. Plan, sections, and details for Secondary Clarifiers 3888, 3892, and 3895. Sewage Disposal Plant Final Sedimentation Tank. Plan CCA-2-5 3S.

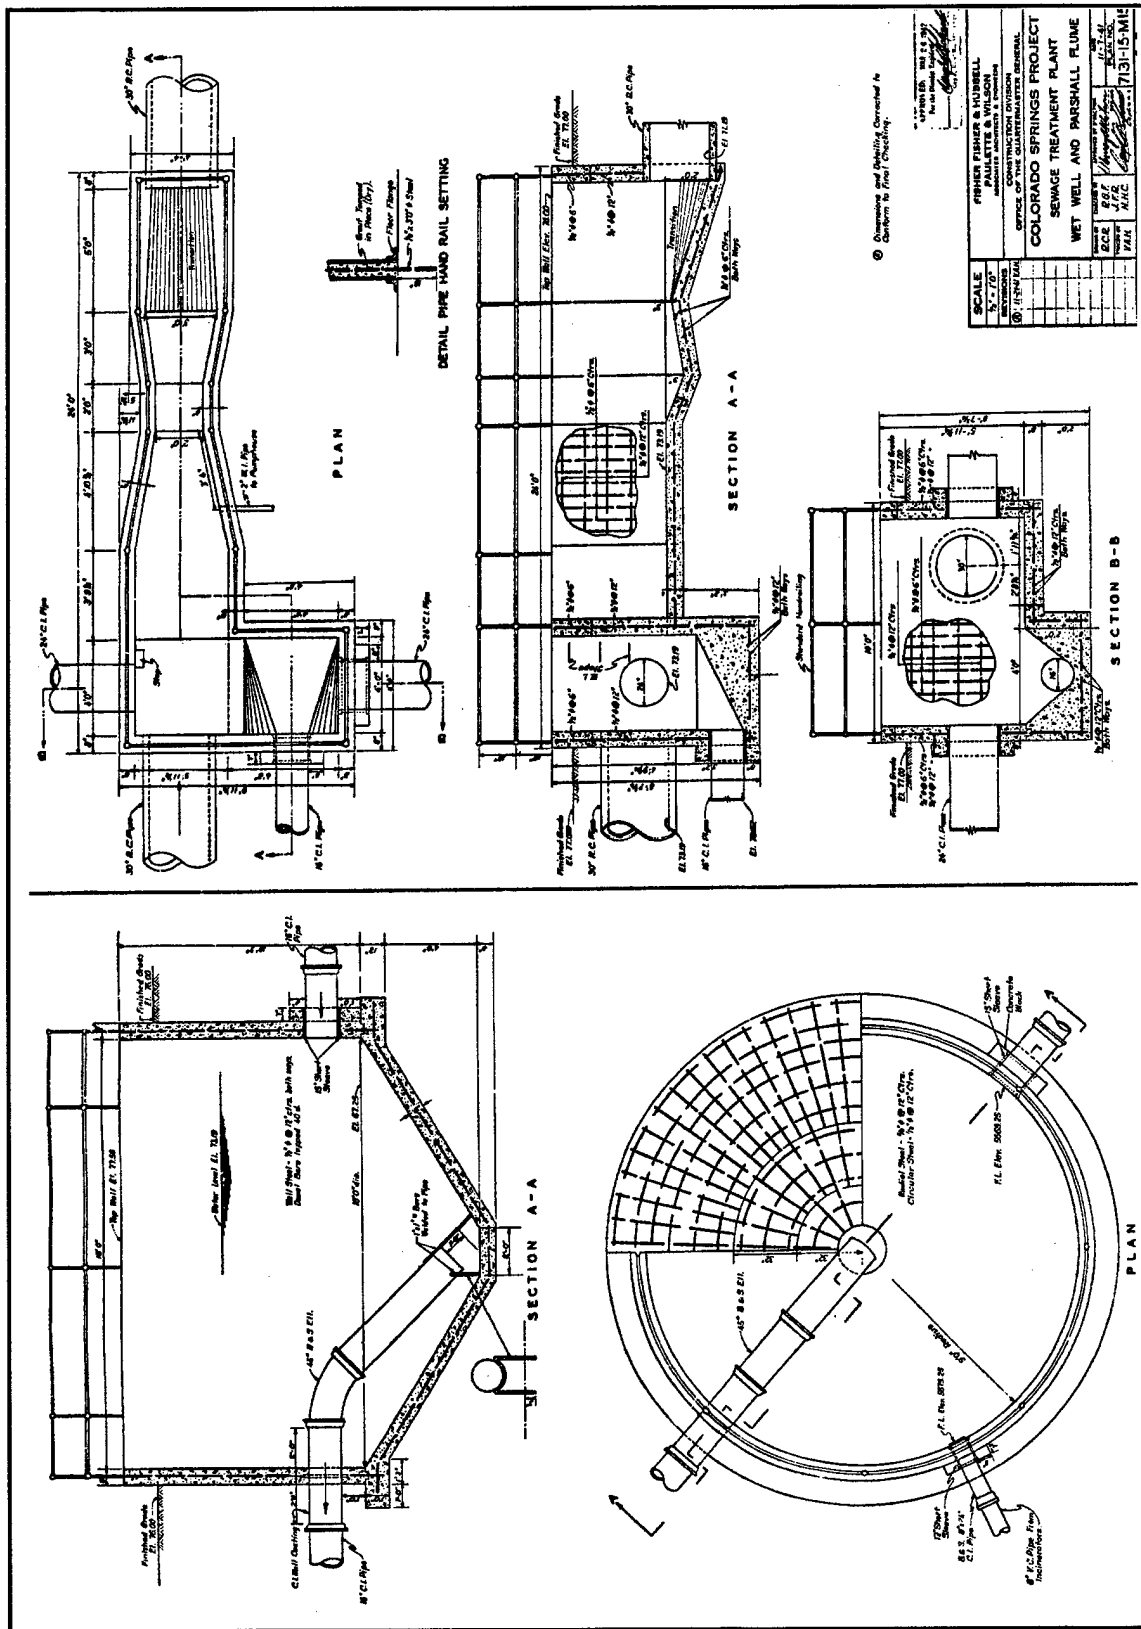
Figure II-28. Plan and section for Recirculation Well 3889; plan and sections for Diversion Box/Parshall Flume 3893. Wet Well and Parshall Flume. Plan 7131-15-M15 2G.

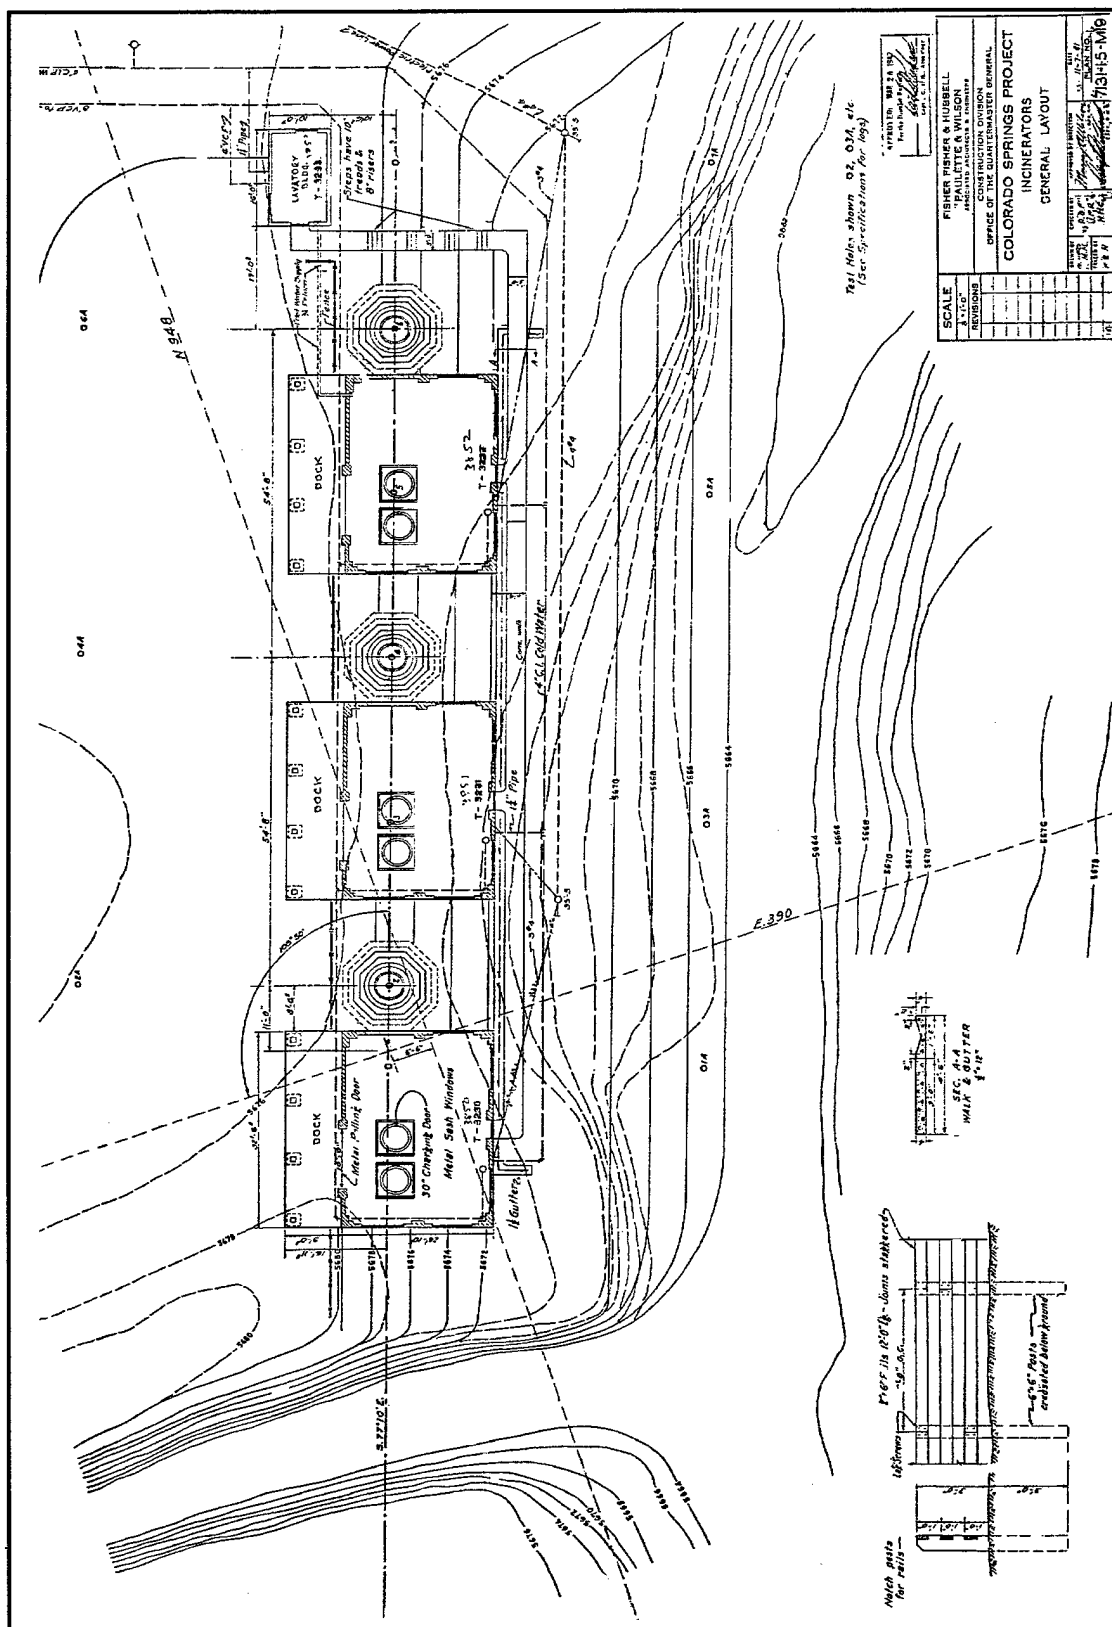
Figure II-30. Plans for Buildings 3850, 3851, and 3852, Incinerators, Plan 7131-15-M19.

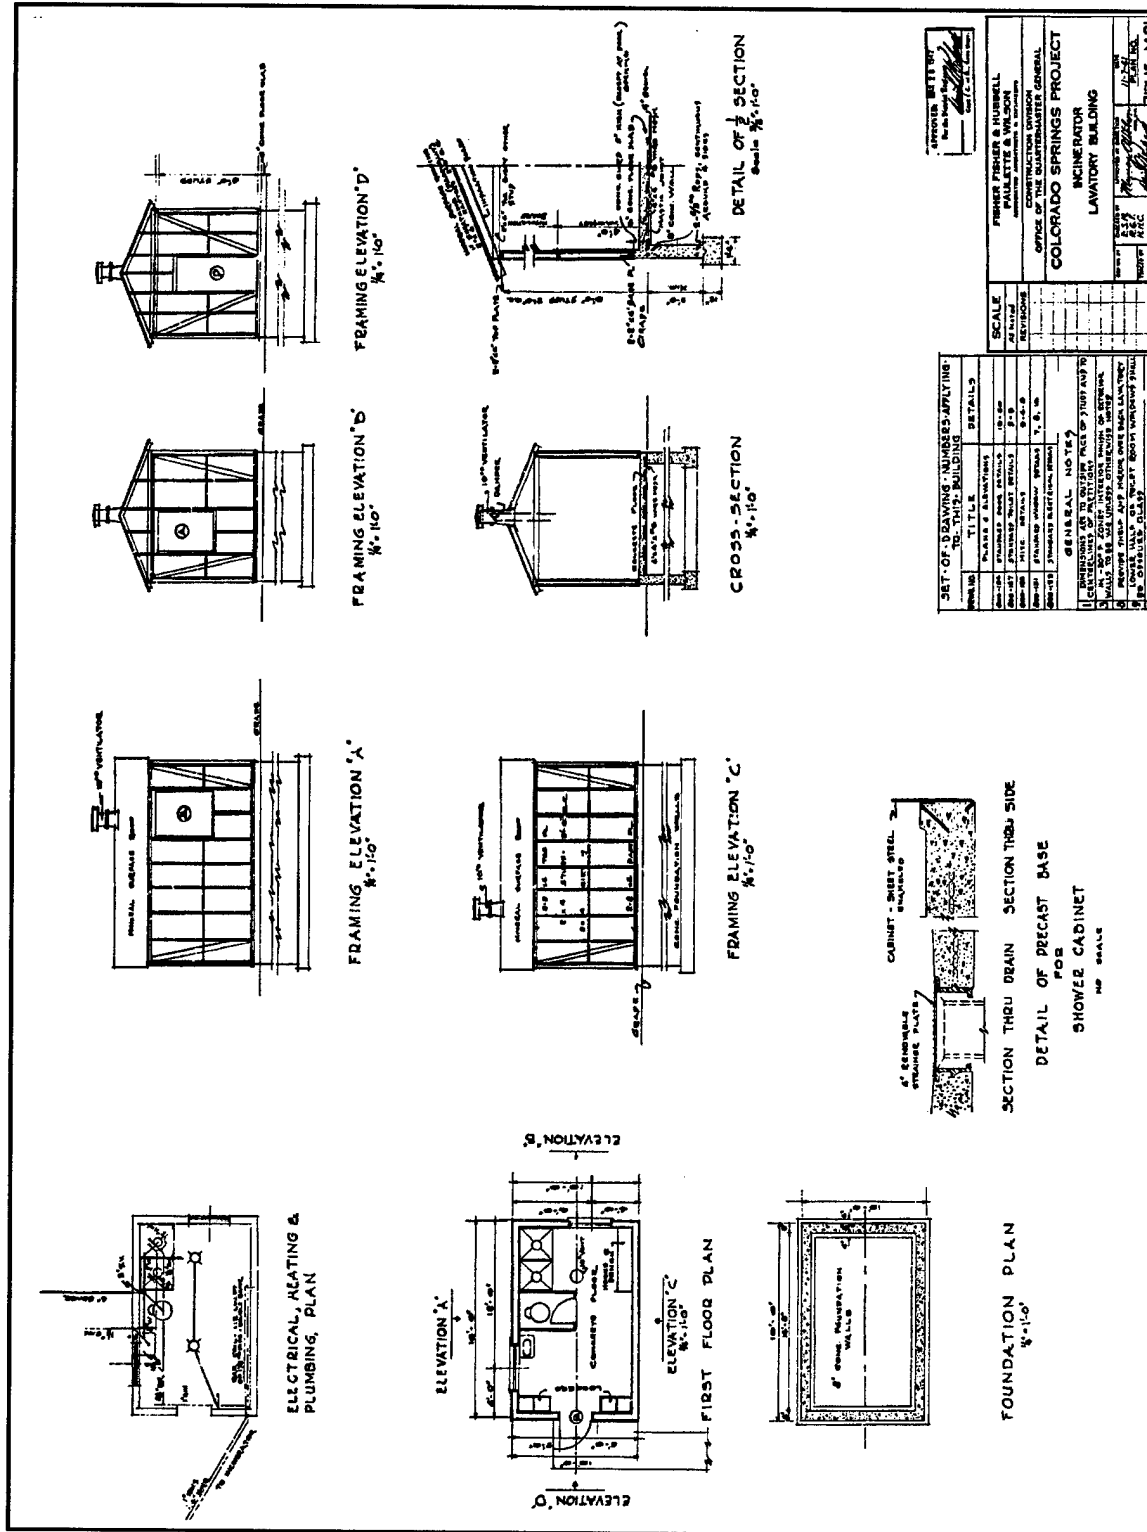
Figure II-31. Plans for Building 3853, Incinerator Lavatory Building, Plan 7131-15-M21 2G.

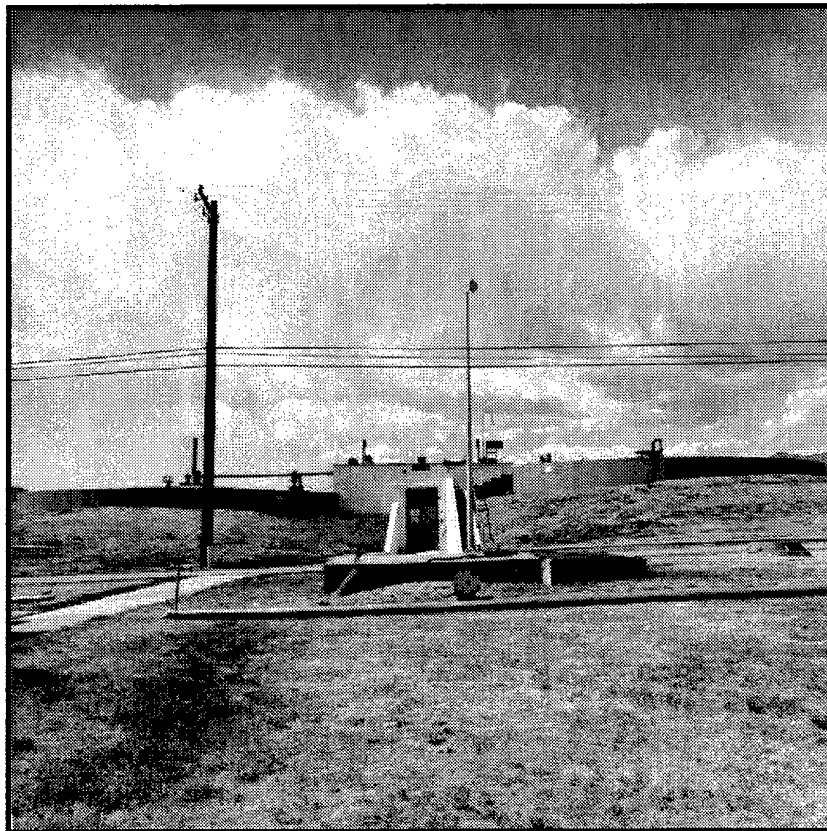
Figure II-32. Frontal View of Digesters 3860 and 3863, and Control Building 3862. View to the Southwest. Roll HH9, Exposure 2.

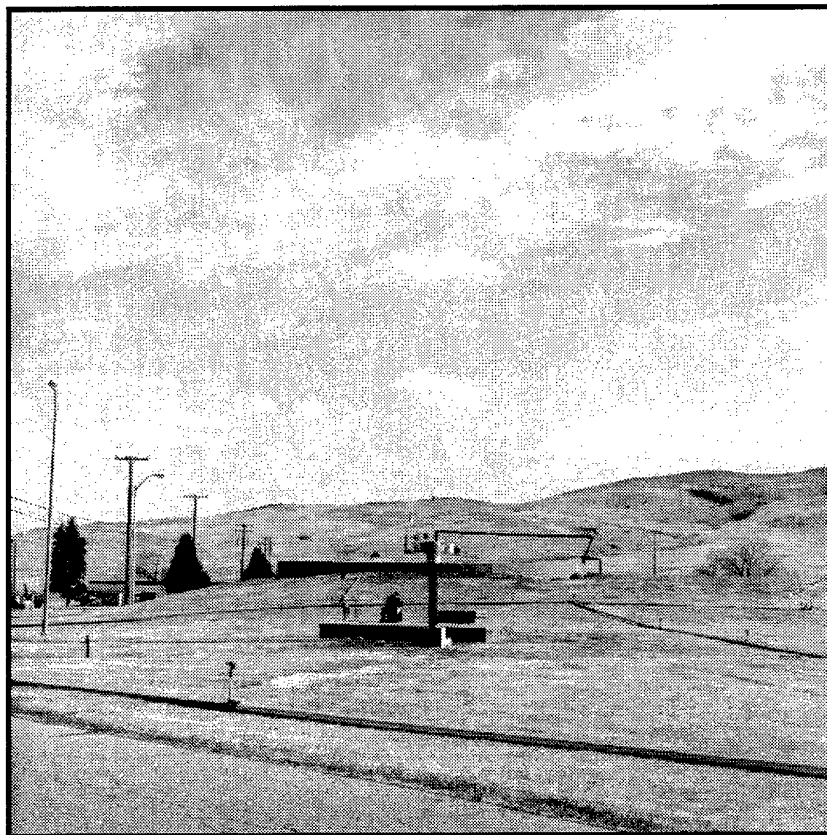
Figure II-34. Side View of Primary Digester 3860. Natural Gas Valve Box and PRV 30 in Foreground. These Process and Burn Methane from Digesters. Roll HH11, Exposure 6.

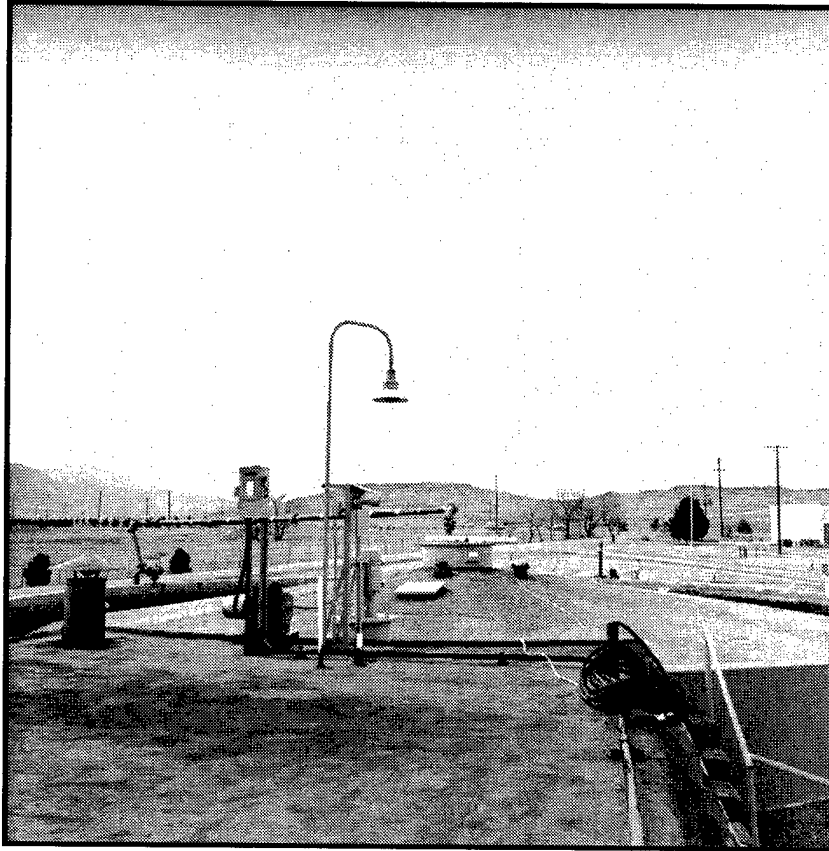
Figure II-35. Detail View of Floating Roof, Primary Digester 3860. Photo from Roof of Control Building. Note Vents, Access Hatches and Gas Collection System. View to the Northwest. Roll HH12, Exposure 2. 222.
